Sewer System Management Plan

Revised January 2014

Sewer System Management Plan (SSMP) January 2014

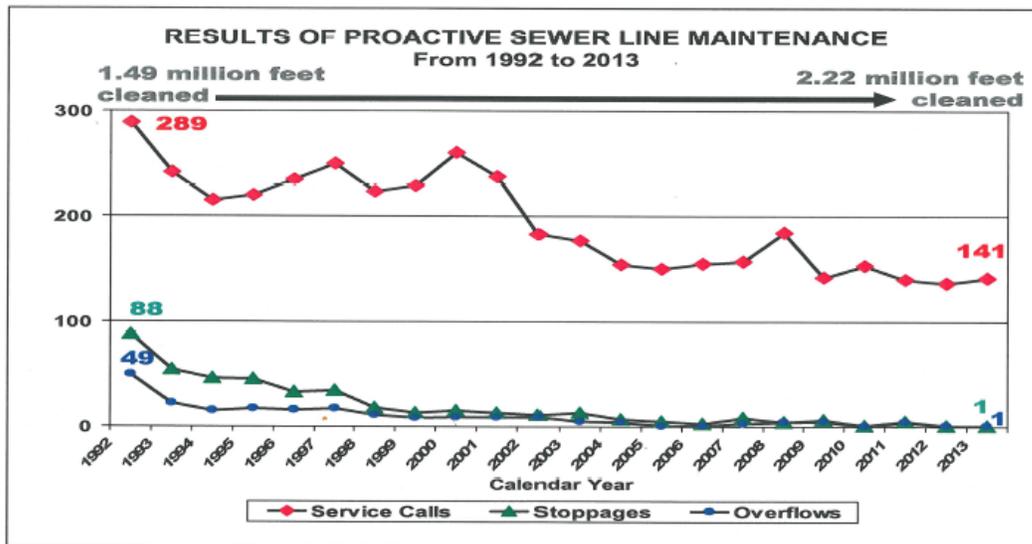
The following table illustrates the correlation between increased sewer cleaning and reduced sewer overflows.

* 2008 service calls showed a slight increase from 2007, as a result of the District's newsletter encouraging customers to report water leaks on the street to reduce sewer overflow response time and duration.
